LAC-PIETE DAM

CALLAWAY COUNTY, MISSOURI

MO 10886

PHASE 1 INSPECTION REPORT NATIONAL DAM SAFETY PROGRAM

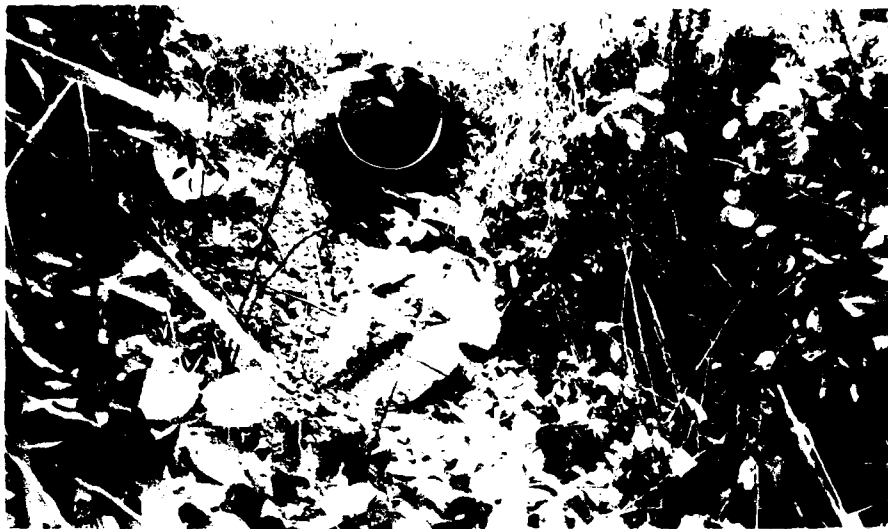
- c. Appurtenant Structures. The spillway is located on the right abutment. It is uncontrolled and consists of an 18 inch corrugated metal pipe about 39 feet long passing through the embankment. The spillway outlets into a poorly defined earth channel running down the slope of the dam. Some erosion was noted at the outlet of the spillway pipe. Several willows are growing around the inlet to the spillway.

PHOTO NO. 2
LOOKING UPSTREAM
AT OUTLET END OF
CORRUGATED METAL
PIPE SPILLWAY

- (1) Trees and heavy vegetation growing on the embankment should be removed.
- (2) The spillway outlet should be improved and stabilized against erosion.
- (3) Erosion on the upstream face of the dam should be corrected.
- (4) A program of regular inspection and maintenance should be initiated. The program should include inspection of all items which could adversely affect the stability of the dam. Records should be kept of all inspections, maintenance, and remedial measures accomplished.

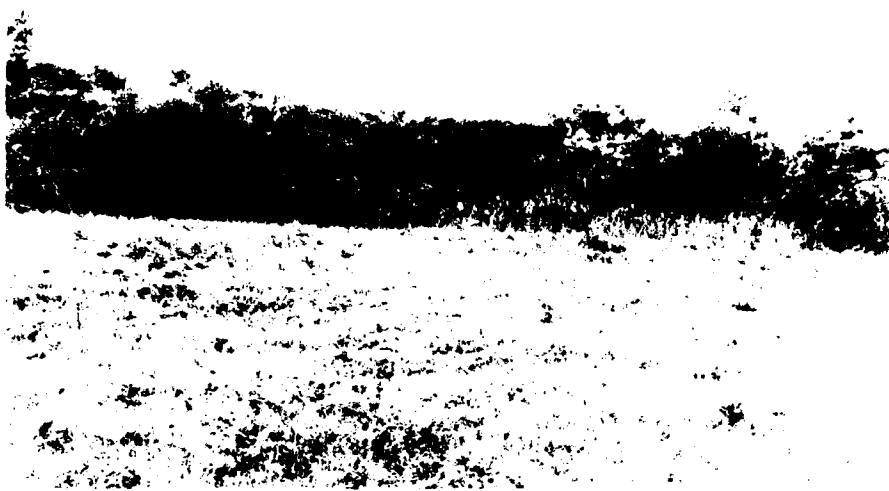
PHOTO NO. 5
LOOKING WEST
ALONG DOWNSTREAM
SLOPE OF DAM.

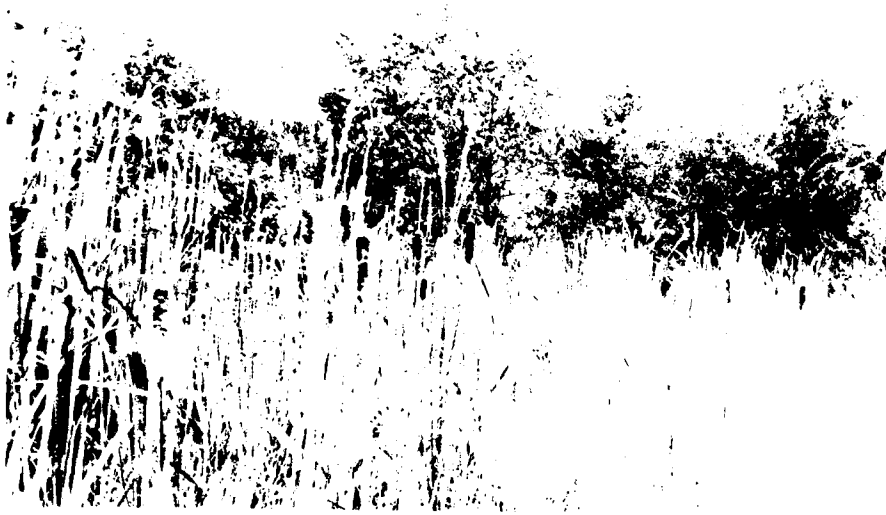
Significant seepage was noted along the downstream toe of the dam from about Q Station 1+00 to 4+50. No boils were observed and seepage appeared to be clear. An 8 inch cast iron sewer line runs along the toe of the dam (approximately Q Stations 5+00 to 3+00)

The tree growth on both slopes of the dam could lead to potential of failure if left uncontrolled. Erosion at the outlet of the spillway could ultimately lead to potential of failure and damage to the sewer line serving the right (east) side of the lake. Additional studies would be required to determine the affects of seepage on the stability of the structure.

PHOTO NO. 6
SEEP AREA BELOW
CENTERLINE STA. 3+50.

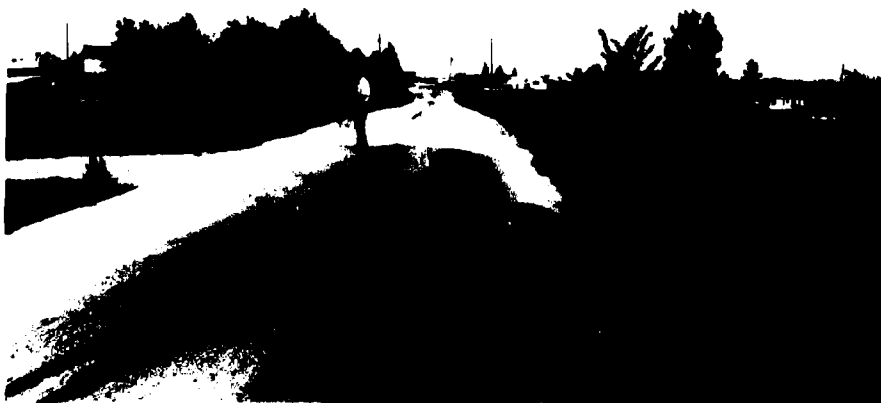
PHOTO NO. 7
LOOKING ALONG
CENTERLINE OF
DAM FROM RIGHT
TO LEFT. COUNTY
ROAD CROSSES DAM.

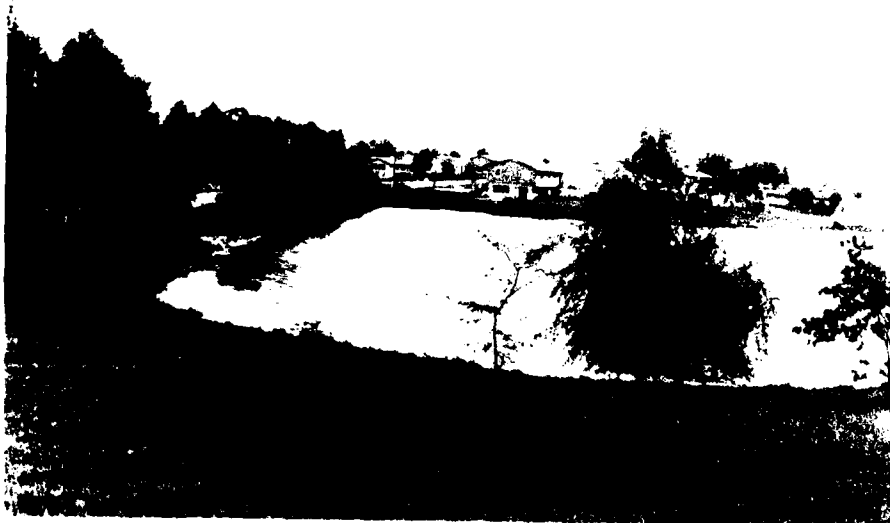
PHOTO NO. 13
TAKEN FROM TOP
OF DAM TO LEFT
AND UPSTREAM.
